1234 Paved Rd.  
Pensacola, FL 32502

Prepared for: Joe and Jane Buyer

Prepared by: Panhandle Construction Group  
9389 Hamman Ave  
Suite C  
Pensacola, FL 32514

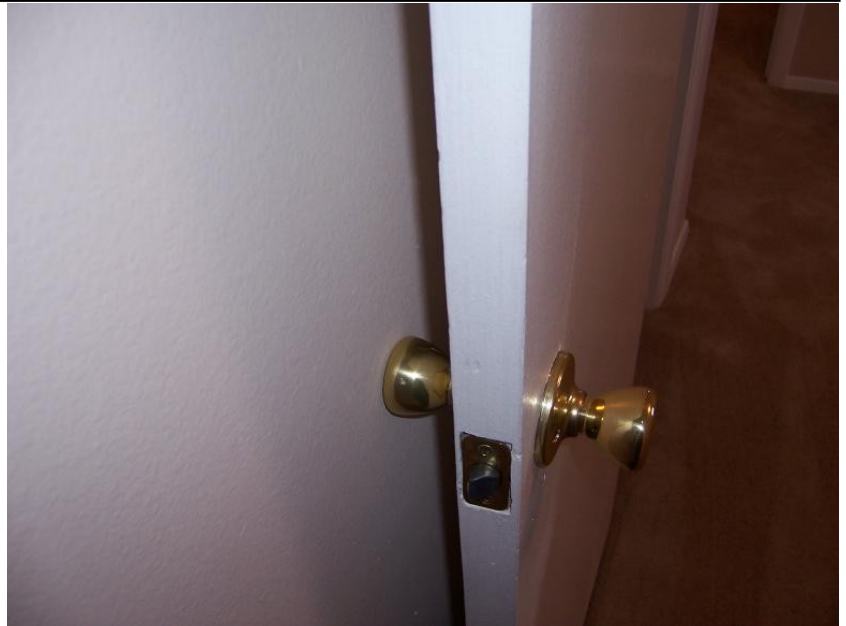
3. Rear Left Bedroom Doors: **Hollow luan: Door bump is damaged at closet door allowing the door knob to hit the wall.**

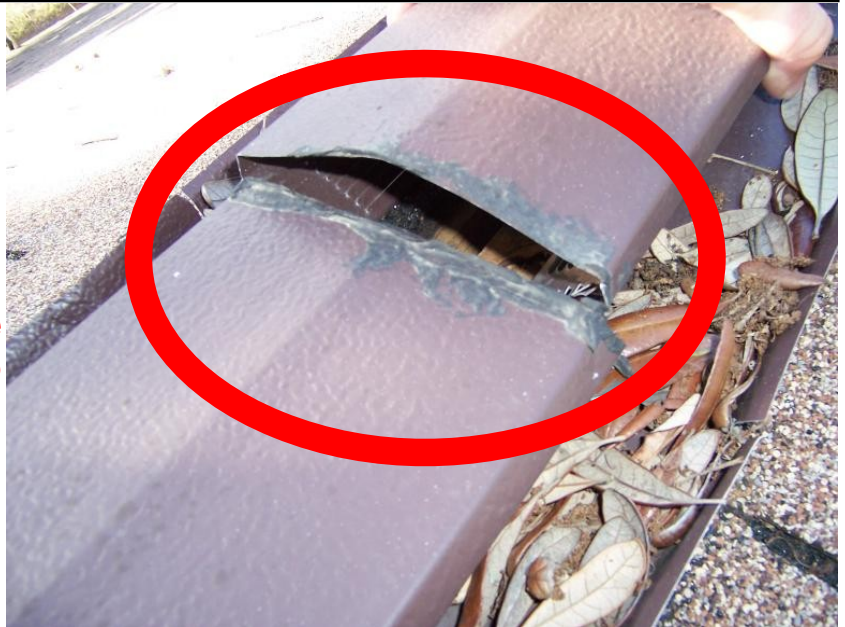
1. Ridge Vent **Aluminum:** The seam at the 2nd story roof is not lapped or sealed properly, thus allowing water into the home. Damage in the form of wood rot was noted to the decking below this ridge vent seam. The decking is not severely deteriorated and does not need to be replaced as long as repair is made to the ridge vent.

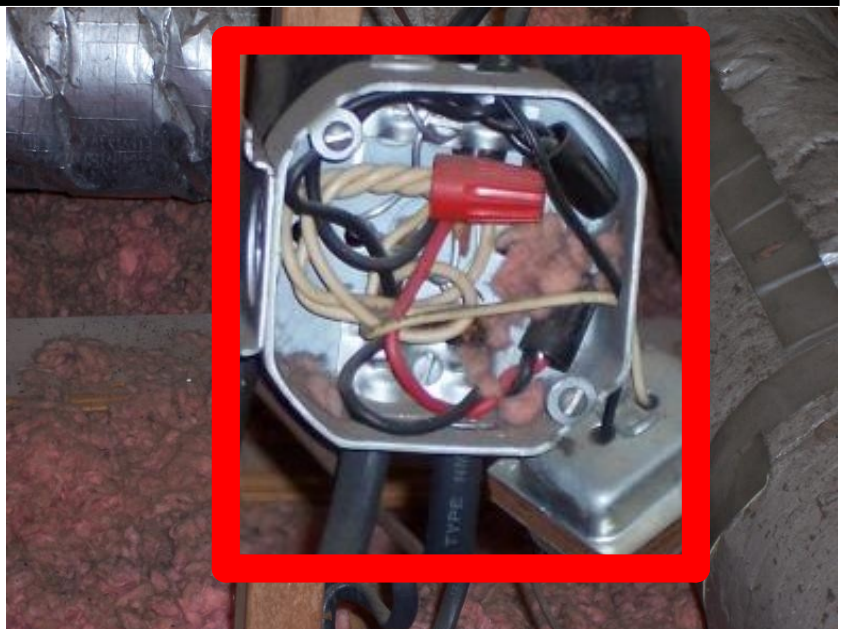
2. Main Attic Wiring/Lighting: **110 VAC:** There is an uncovered junction box in the attic. This is both a fire and electric shock hazard. A cover should be placed over the box.

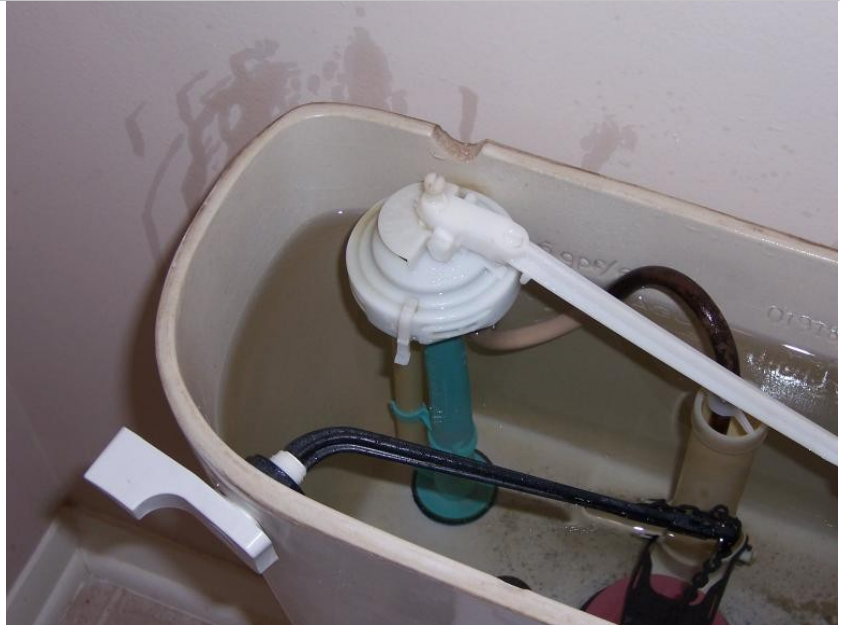
3. Half bath Bathroom Toilets: **Quasar: Valve in tank sprays water out of top of tank.**

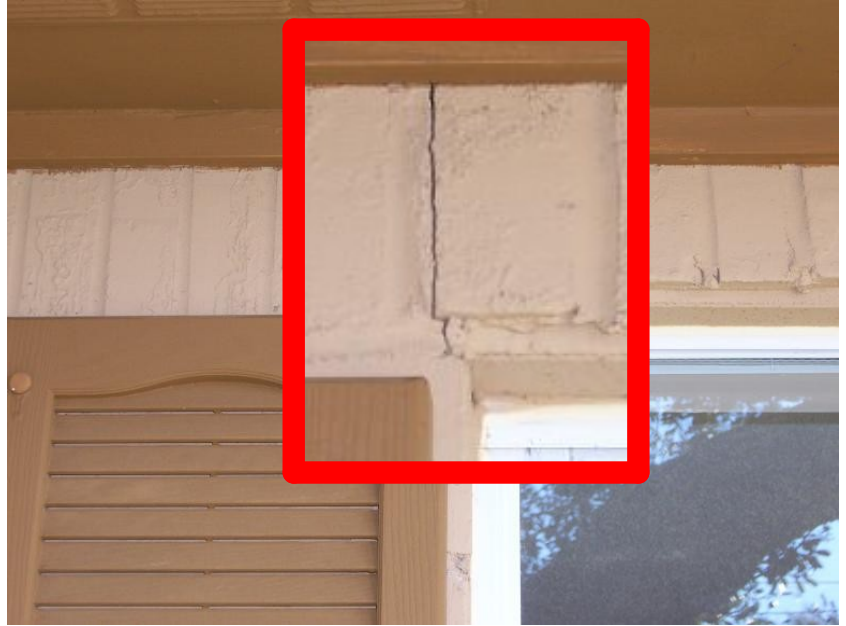
Type: **Brick veneer:**  
**There are cracks in several areas in the brick mortar. These cracks are NOT considered to be structural defects.**

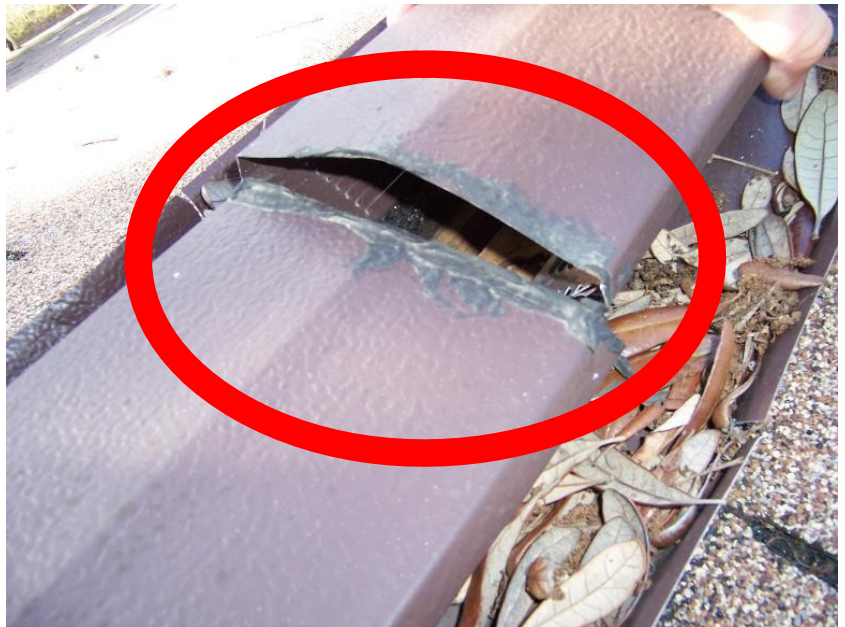
1. Method of Inspection: **On roof**
2. **Acceptable**      Unable to Inspect: **0**
3. **Acceptable**      Material: **Asphalt shingle**
4. Type: **Gable**
5. Approximate Age: **2 years**
6. **Acceptable**      Flashing: **Aluminum**
7. **Not Present**      Valleys:
8. **Defective**      Ridge Vent **Aluminum:**

**The seam at the 2nd story roof is not lapped or sealed properly, thus allowing water into the home. Damage in the form of wood rot was noted to the decking below this ridge vent seam. The decking is not severely deteriorated and does not need to be replaced as long as repair is made to the ridge vent.**

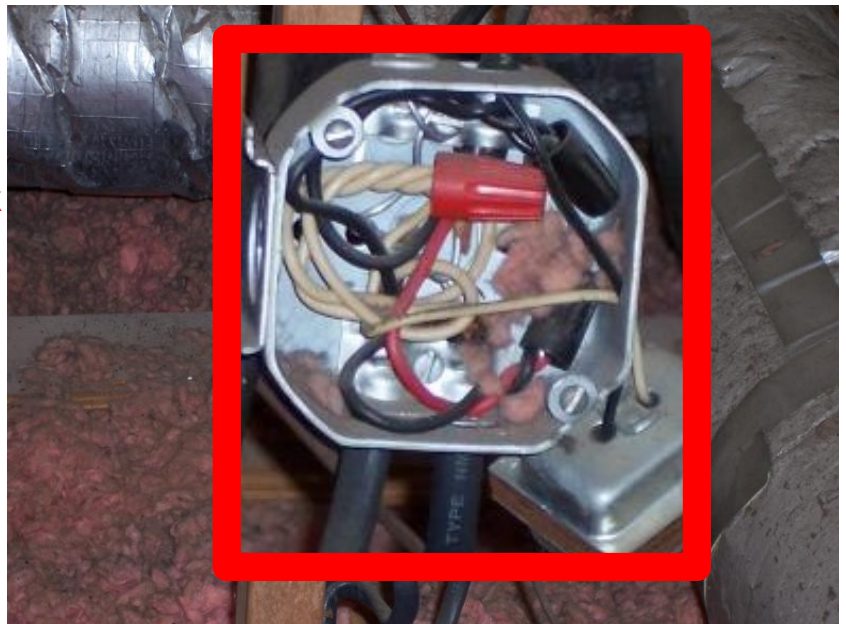
1. Method of Inspection: **In the attic**
2. **Acceptable** Unable to Inspect: **25%**
3. **Acceptable** Roof Framing: **2x6 Rafter**
4. **Acceptable** Sheathing: **Plywood**
5. **Acceptable** Ventilation: **Ridge and soffit vents**
6. **Marginal** Insulation Depth: **6"**
7. **Not Present** Vapor Barrier:
8. **Not Present** Attic Fan:
9. **Not Present** House Fan:
10. **Defective** Wiring/Lighting: **110 VAC:**

**There is an uncovered junction box in the attic. This is both a fire and electric shock hazard. A cover should be placed over the box.**

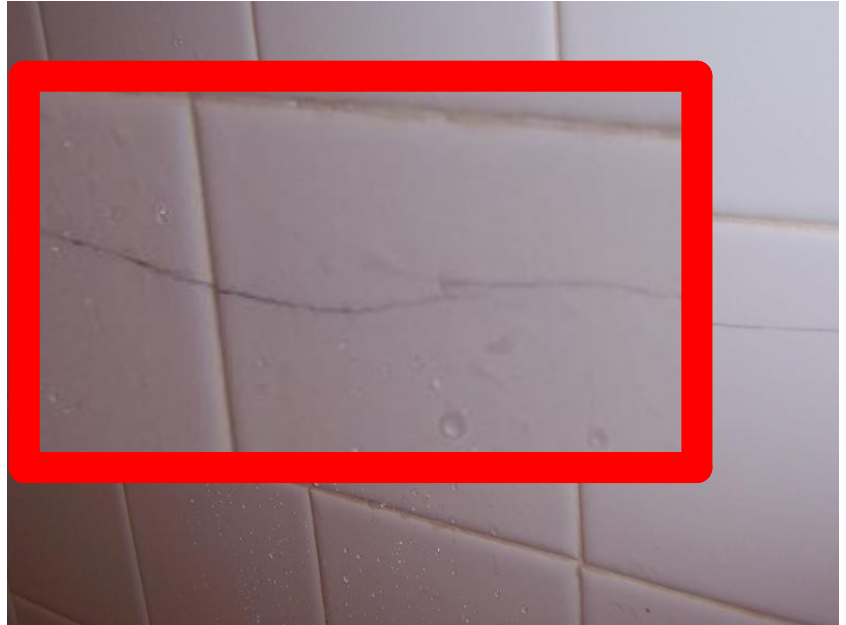
1. **Not Present** Closet:
2. **Acceptable** Ceiling: **Popcorn Texture**
3. **Acceptable** Walls: **Paint**
4. **Acceptable** Floor: **Vinyl floor covering**
5. **Acceptable** Doors: **Hollow luan**
6. **Not Present** Windows:
7. **Acceptable** Electrical: **110 VAC GFCI**
8. **Acceptable** Counter/Cabinet: **Laminate and wood**
9. **Acceptable** Sink/Basin: **Porcelain coated**
10. **Acceptable** Faucets/Traps: **Delta fixtures with a metal trap**
11. **Acceptable** Tub/Surround: **Porcelain tub and ceramic tile surround: There is a horizontal crack in rear tile wall.**

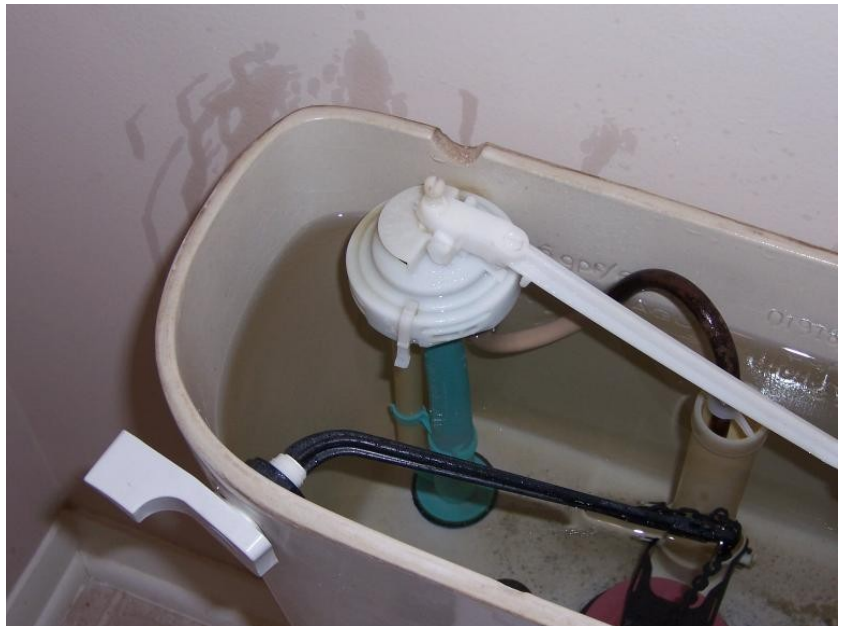
- 33. **Not Present** Closet:
- 34. **Acceptable** Ceiling: **Popcorn Texture**
- 35. **Acceptable** Walls: **Paint**
- 36. **Acceptable** Floor: **Vinyl floor covering**
- 37. **Acceptable** Doors: **Hollow luan**
- 38. **Not Present** Windows:
- 39. **Acceptable** Electrical: **110 VAC outlets and lighting circuits**
- 40. **Not Present** Counter/Cabinet:
- 41. **Acceptable** Sink/Basin: **Pedestal**
- 42. **Acceptable** Faucets/Traps: **Delta fixtures with a PVC trap**
- 43. **Not Present** Tub/Surround:
- 44. **Not Present** Shower/Surround:
- 45. **Not Present** Spa Tub/Surround:
- 46. **Defective** Toilets: **Quasar: Valve in tank sprays water out of top of tank.**

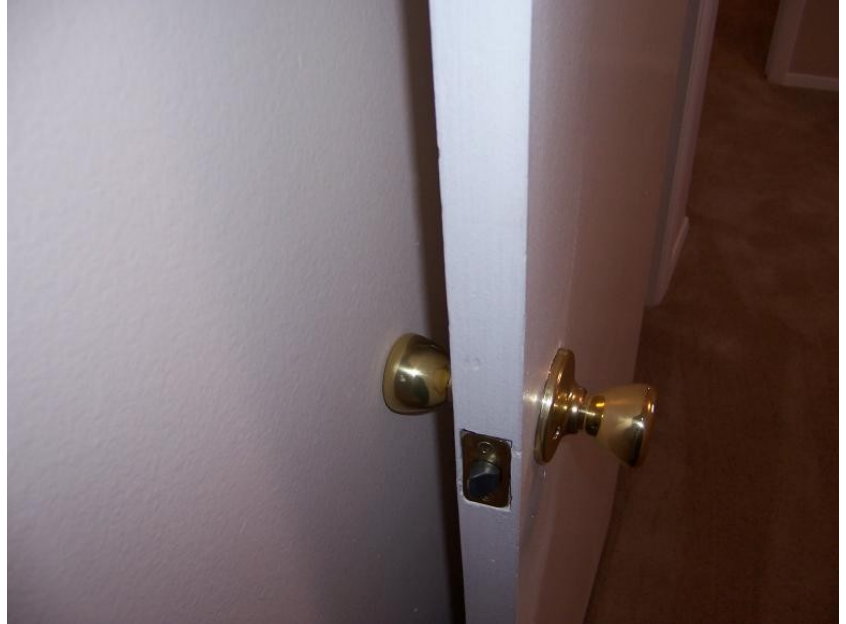
23. **Marginal**

Doors: **Hollow luan:**  
**Door bump is**  
**damaged at closet**  
**door allowing the**  
**door knob to hit the**  
**wall.**
