1234 Paved Rd.  
Pensacola, FL 32502

Prepared for: Joe and Jane Buyer

Prepared by: Panhandle Construction Group  
9389 Hamman Ave  
Suite C  
Pensacola, FL 32514

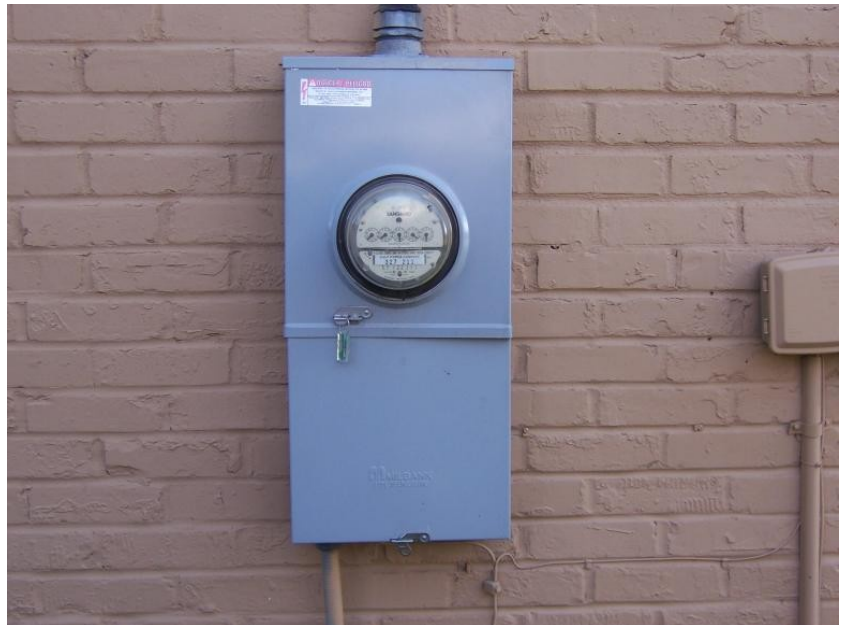
1. Service Size Amps: **200** Volts: **110-240 VAC**
  2. **Acceptable** Service: **Copper and aluminum**
  3. **Acceptable** 120 VAC Branch Circuits: **Aluminum**
  4. **Acceptable** 240 VAC Branch Circuits: **Aluminum**
  5. **Acceptable** Aluminum Wiring: **Localized circuits 1st Floor**
  6. **Acceptable** Conductor Type: **Romex**
  7. **Acceptable** Ground: **Rod in ground only**
- Left side Electric Panel
8. **Acceptable** Manufacturer: **Milbank**

9. Maximum Capacity: **200 Amps**
10. **Acceptable** Main Breaker Size: **90 amp**
11. **Acceptable** Breakers: **Copper and Aluminum**
12. **Acceptable** Fuses: **Blade type**
13. **Not Present** AFCI:
14. **Acceptable** GFCI: **At GFCI receptacles only**
15. Is the panel bonded? **No**

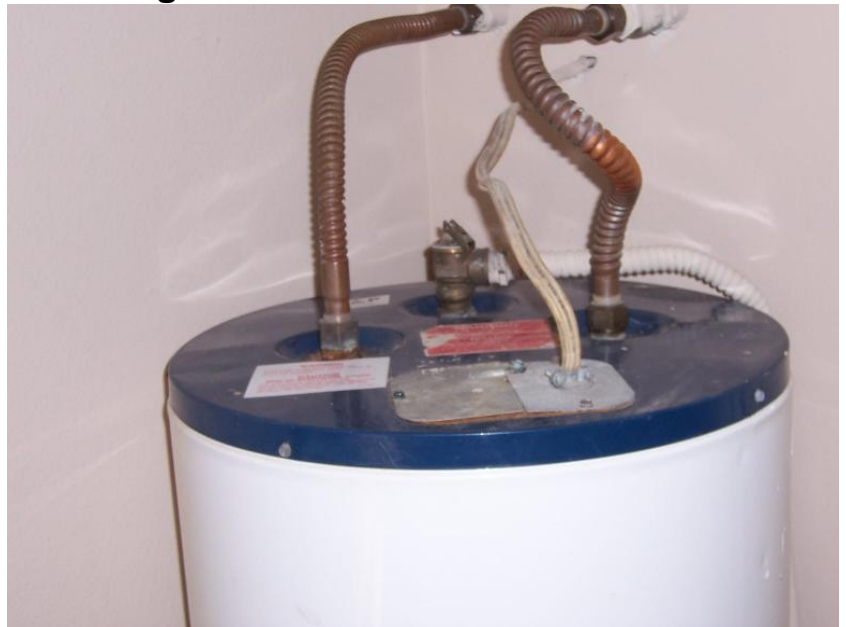
1. **Acceptable** Service Line: **not determined**  
2. **Acceptable** Main Water Shutoff: **Front of house**  
3. **Acceptable** Water Lines: **Copper**  
4. **Acceptable** Drain Pipes: **PVC**  
5. **Not Inspected** Service Caps:  
6. **Acceptable** Vent Pipes: **PVC**  
7. **Not Present** Gas Service Lines:  
Utility Room Water Heater
- 
8. **Acceptable** Water Heater Operation: **Functional at time of inspection**  
9. Manufacturer: **American**  
10. Model Number: **E51-40R** Serial Number: **9440117844ATV**  
11. Type: **Electric** Capacity: **40 Gal.**  
12. Approximate Age: **5 Years** Area Served: **Whole building**  
13. **Not Present** Flue Pipe:

14. **Acceptable** TPRV and Drain Tube: **PVC: TPR valve tested properly.**

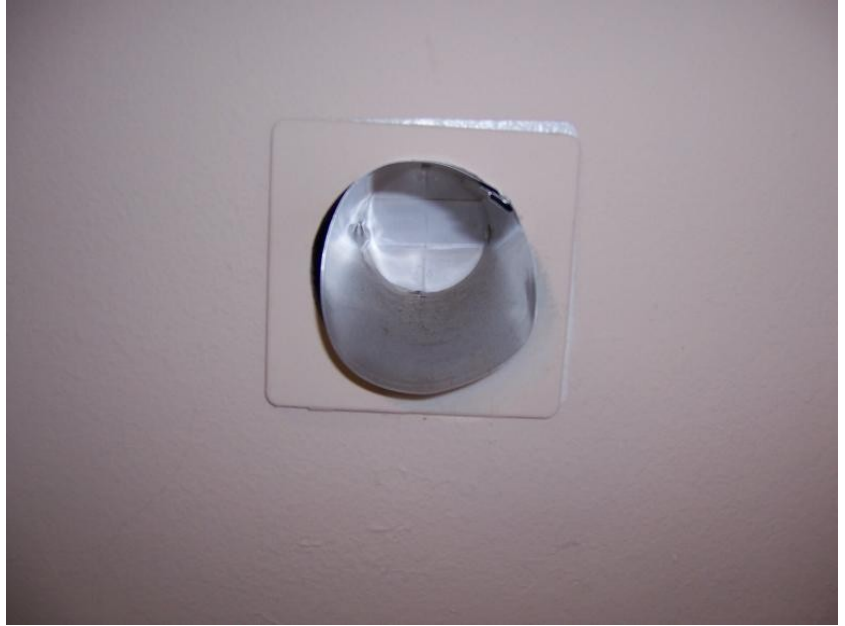
14. **Acceptable** Dryer Vent: **Rigid metal**
